Failure Analysis and Mechanical Tests of Failed Aluminum Alloy 7277 Rivets on Armored Vehicle Launched Bridges

ARL-TR-1195

September 1996

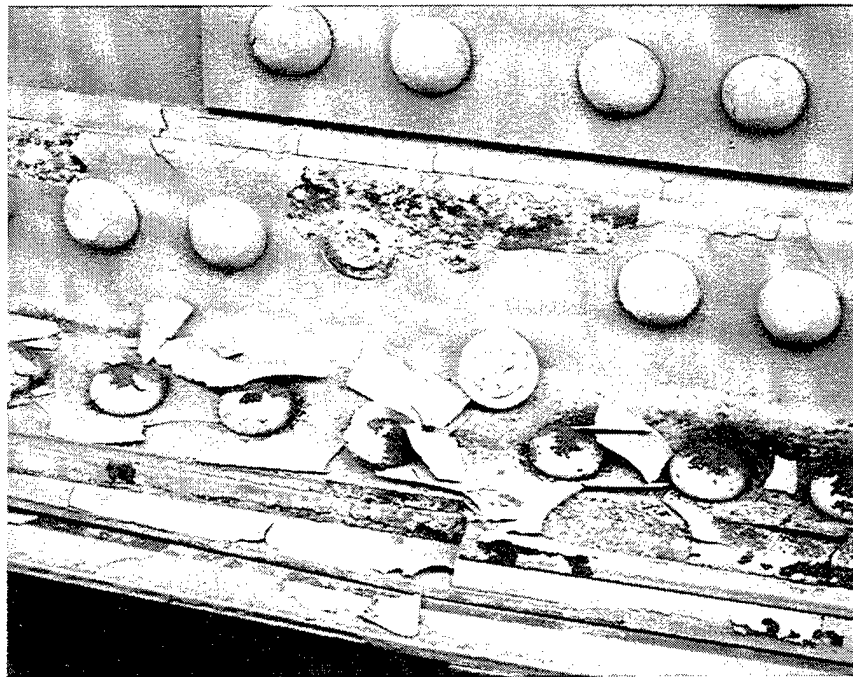
Figure 2. A view of the splice joint in the bottom chord of the AVLB from SWA, showing a failed aluminum rivet with its head already popped off. Note the white areas of the corrosion products formed on the surfaces of the fracture under the failed head as well as on the structural angle where the paint coating had flaked off.

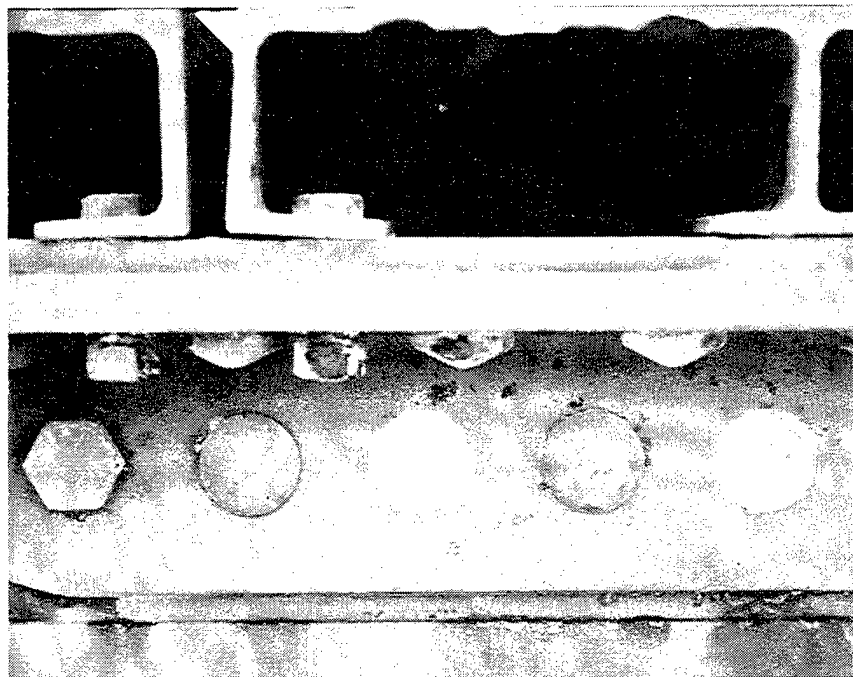
Figure 3. A view of a top chord connector of the AVL B from SWA, showing two failed aluminum rivets with their head already fallen off. The white circular areas are the corrosion products formed under the head at the shoulder and crack fracture. Note the steel bolt at far left which apparently was used to replace the rivet that failed earlier.

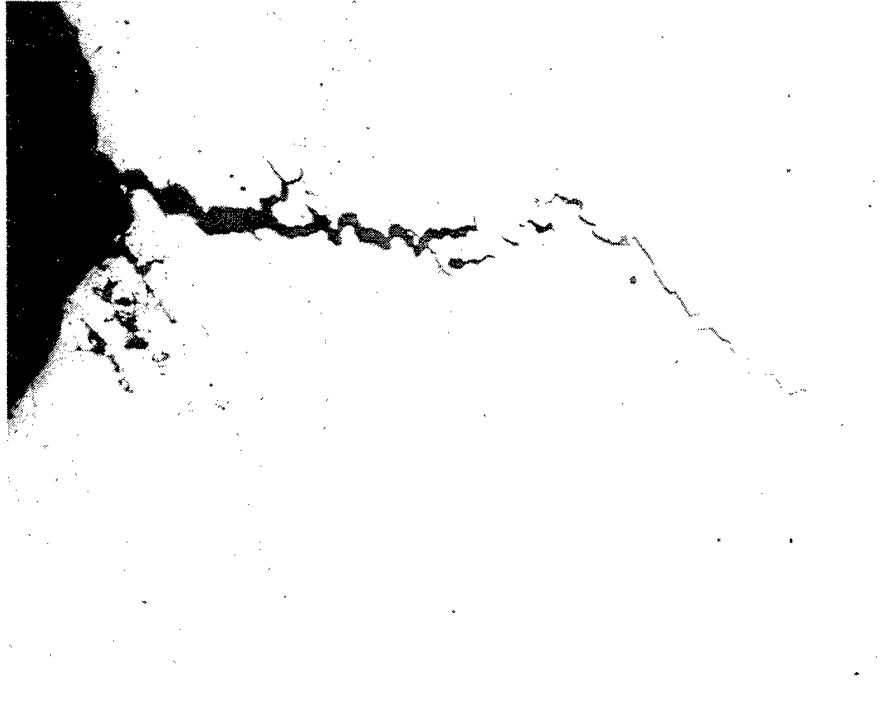
Figure 6. As-polished microstructure of the failed aluminum rivet head showing a small secondary crack in the future. Magnification: 150x.

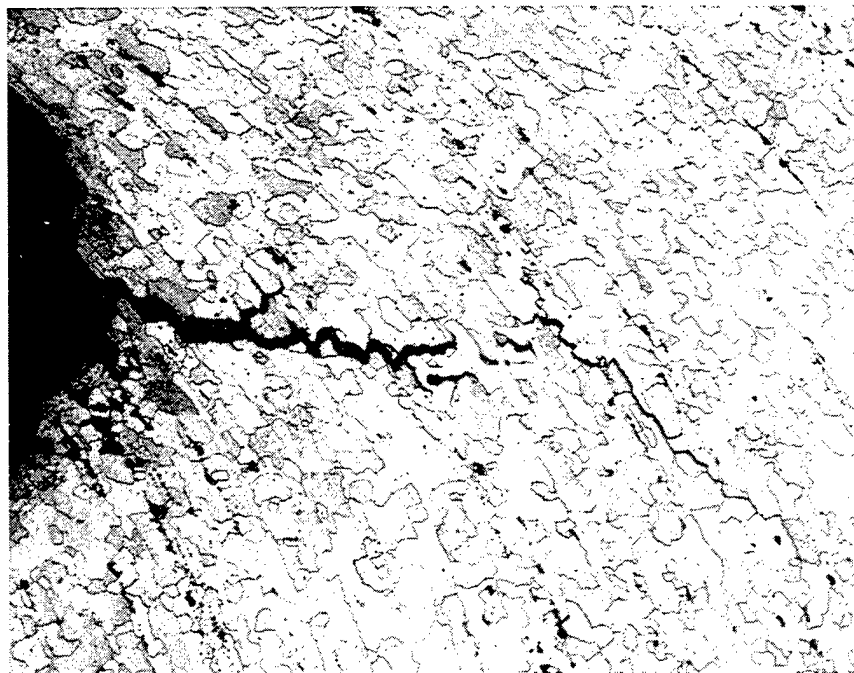
Figure 7. Etched microstructure of the same area in Figure 6 revealing that the crack is predominantly intergranular, indicative of stress corrosion cracking. The tail end of the crack had followed the grain flow formed as the result of the cold head-forming process by the rivet manufacturer. Magnification: 150x. Keller's etchant.

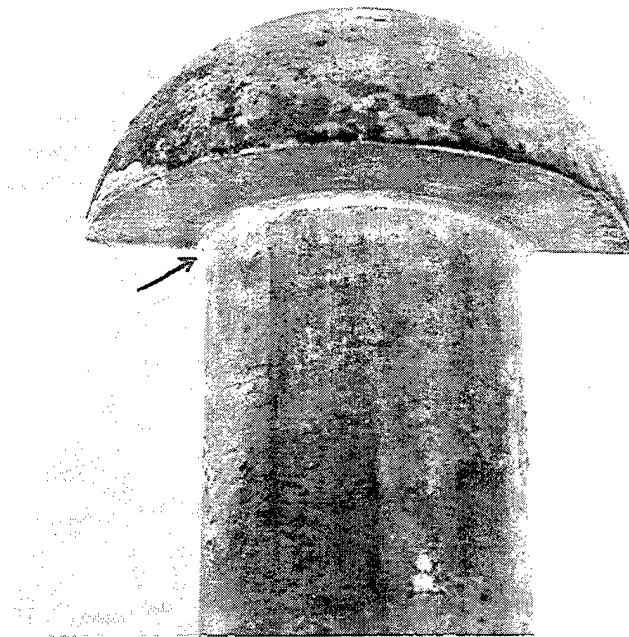
Figure 8. A view of a large aluminum rivet removed from a forged aluminum center hinge of one AVLB from SWA stored at ANAD. A small white corrosion deposit (arrow) can be seen in the head-to-shank fillet. A section of the head and shank with the corroded area was already cut off for microstructural examination. Magnification: 2x.

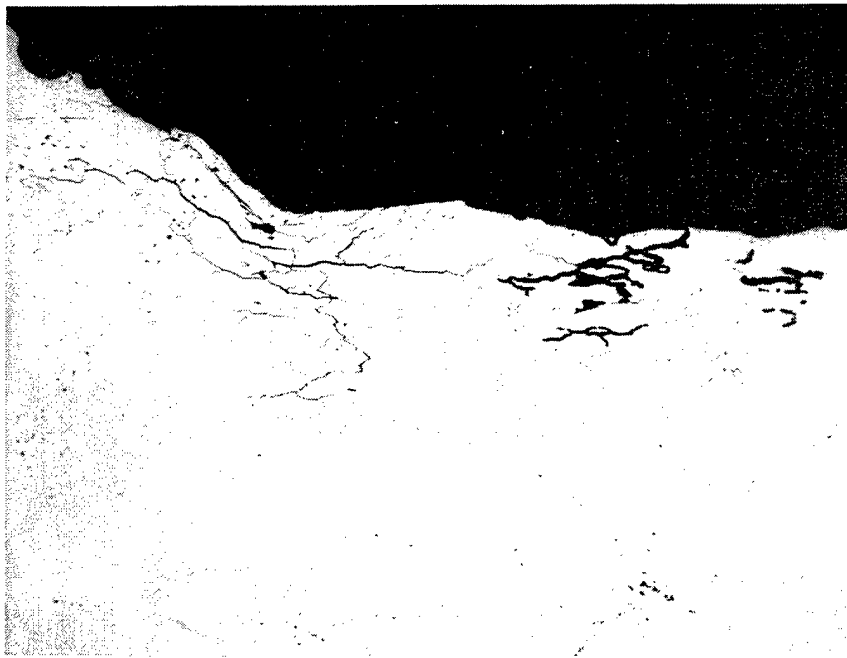
Figure 9. As-polished microstructure of the aluminum rivet in Figure 8. Intergranular corrosion and cracks are present in the small corroded area in head-to-shank fillet, indicative of stress corrosion cracking. Magnification: 170x.

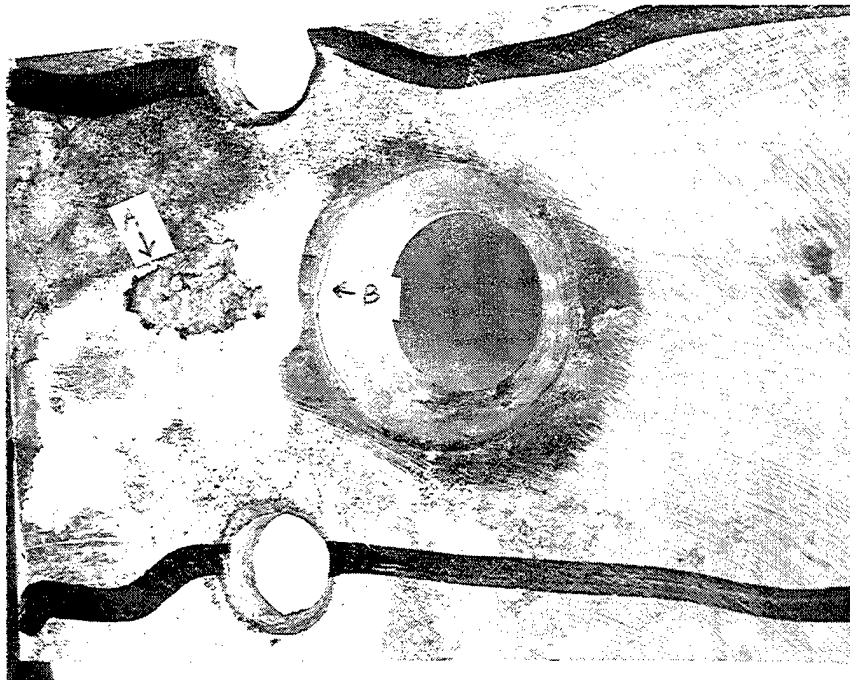
Figure 11. Large corroded hole (A) on top surface of the top chord angle section cut from AVLB center panel dismantled at ANAD. Exfoliation had extended laterally beyond the hole of the corroded area. Delaminated surface crack (B) due to exfoliation was observed near the top of the large countersunk rivet hole. Slightly larger than actual size.

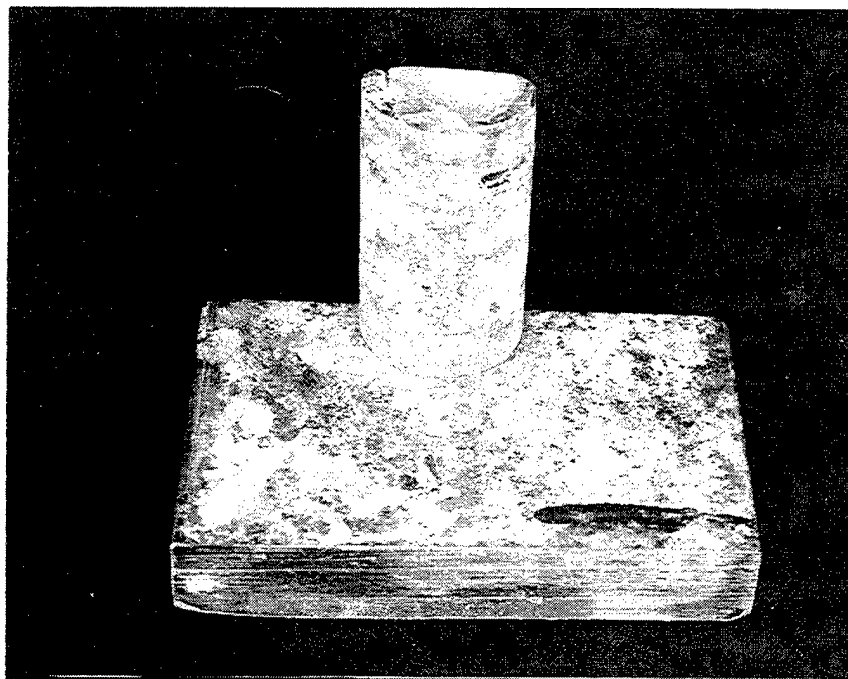
Figure 14. A section of the aluminum rivet shank still in the rivet hole of the spacer bar removed from the AVL B center panel assembly dismantled at ANAD. The bare surfaces of the rivet and bar were heavily covered with the white corrosion products. This sample was already cut in two for metallurgical examination. Magnification: approximately 1.25 \times .

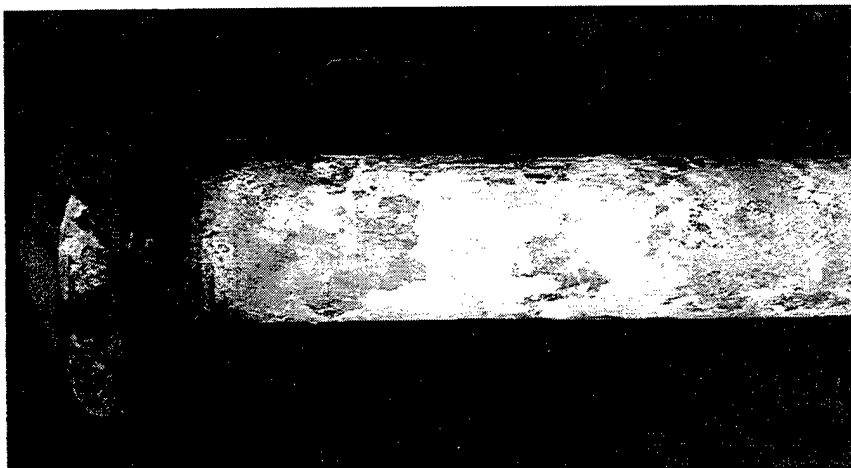
Figure 17. A 4-in-long large aluminum rivet sample with heavy deposits of white corrosion products on the surface of its shank. The driven end of the rivet is on left. Slightly larger than actual size.

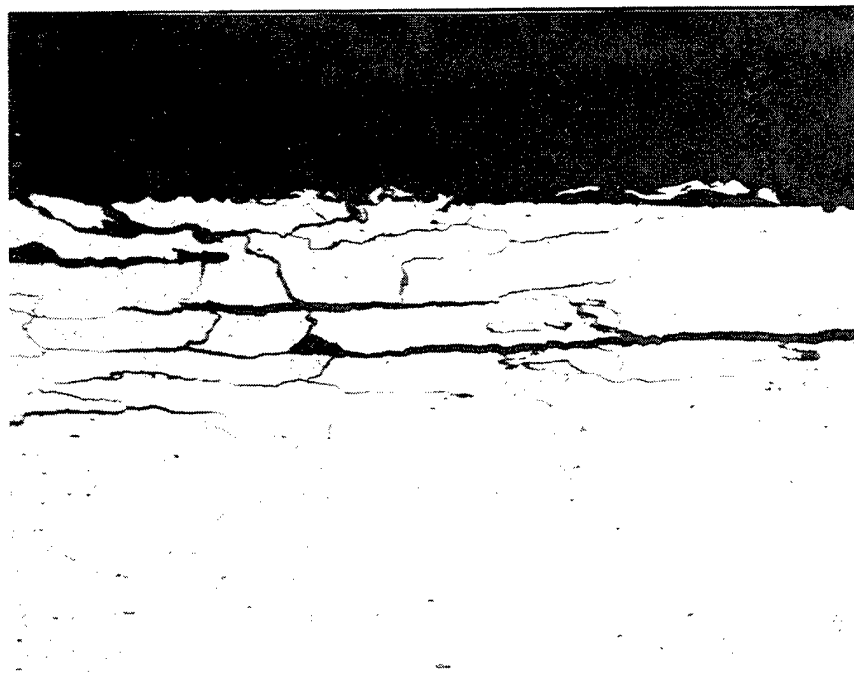
Figure 18. As-polished microstructure of a small corroded area on the surface of the rivet shank in Figure 17 covered with thick corrosion products. Intergranular corrosion and cracks (SCC) were observed at the corroded surface. Magnification: 100 \times .

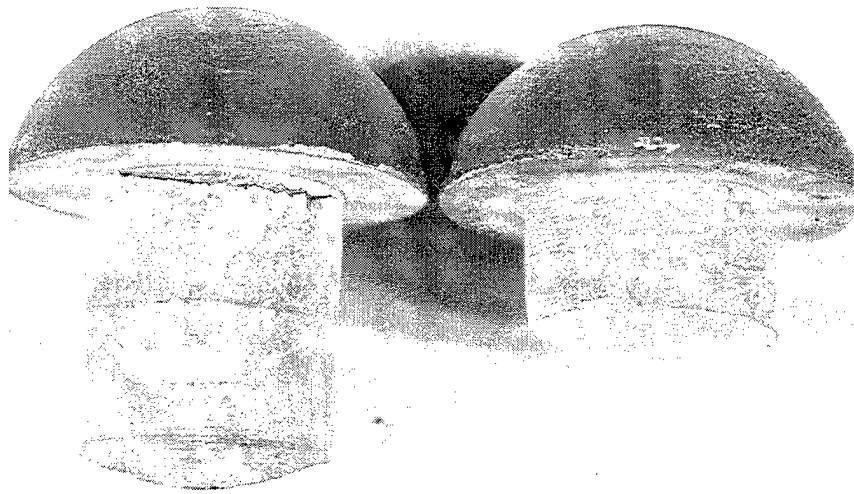
Figure 23. View of "Bad" (left) and "Good" rivets after the shear tests. A large crack is seen in the head-to-shank fillet of the "Bad" rivet. White corrosion products were on the surface of the rivet shank of both rivets. Magnification: approximately 1.33 \times .

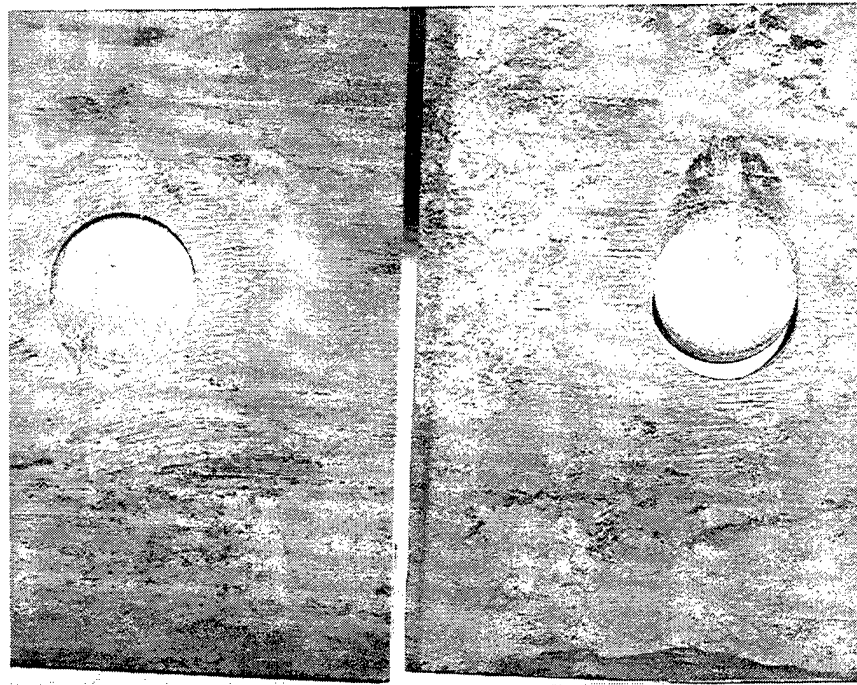
Figure 25. View of the rivet holes in the angle vertical leg on left and in the girder plate plunger on right after the shear test. Elongation of the rivet hole in the plate plunger was greater than the hole in the angle leg as noted by the gap. Sheared sections of the rivet shank remained in the holes. Actual size.

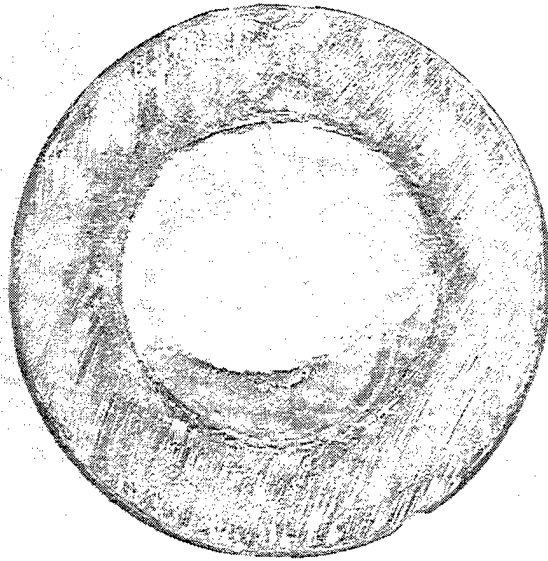
Figure 29. Enlarged view of the fracture surface of the rivet head (specimen C) that broke at the head-to-shoulder fillet after the pull test, revealing the darkened area of the crack because of corrosion (stress corrosion cracking).

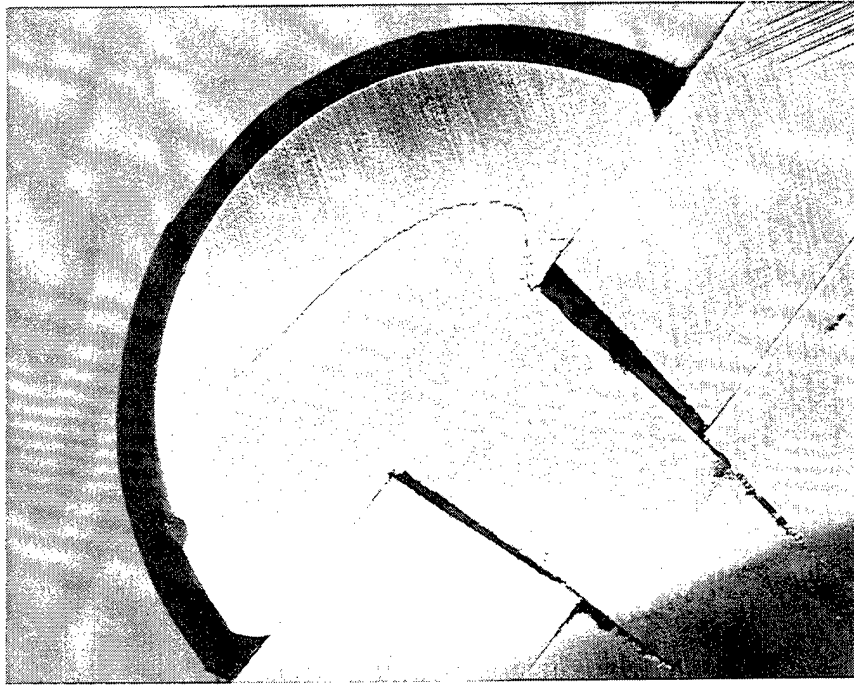
Figure 31. A view of the cross section of the installed rivet showing a large crack in the head. The crack initiated in the fillet. Magnification: 3x. As-polished.

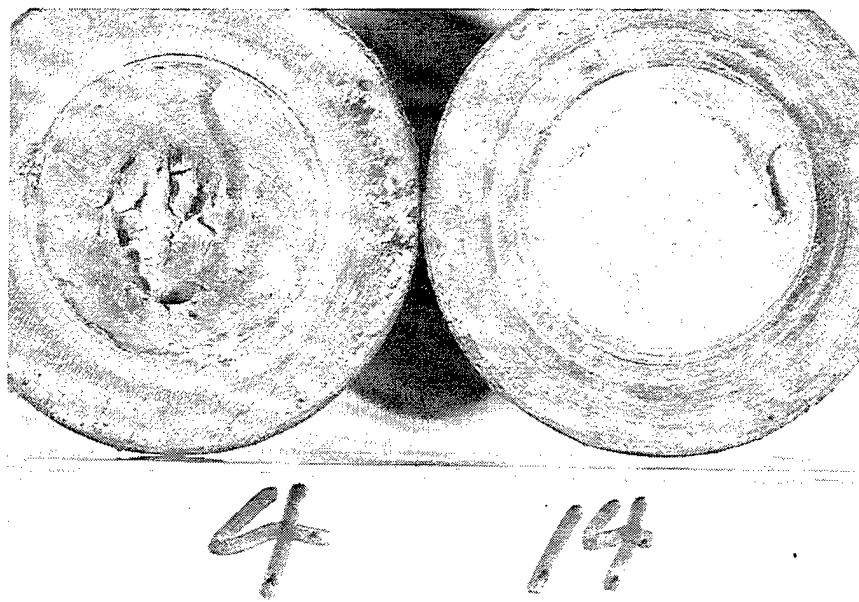
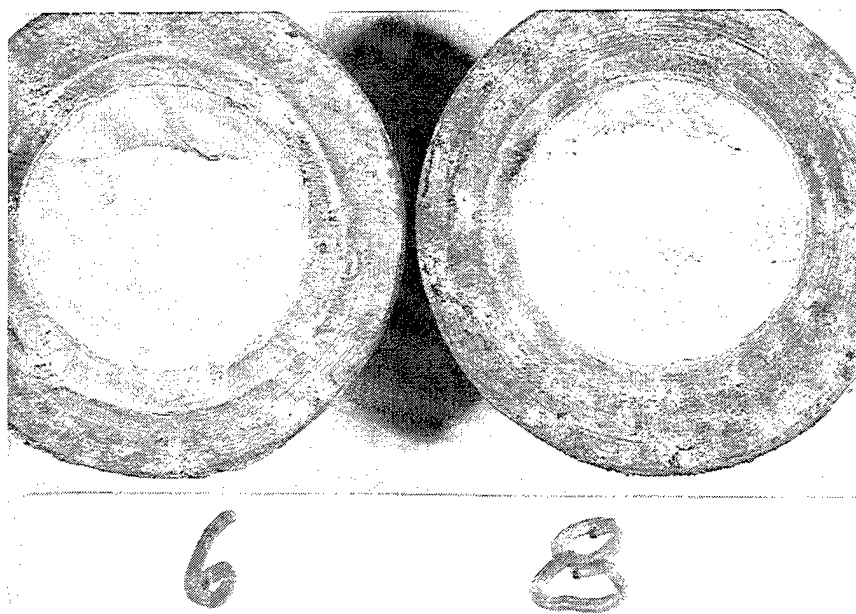
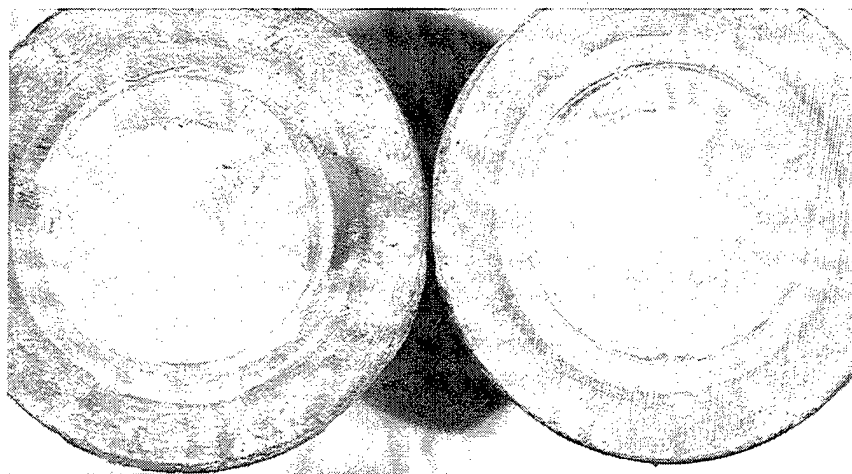
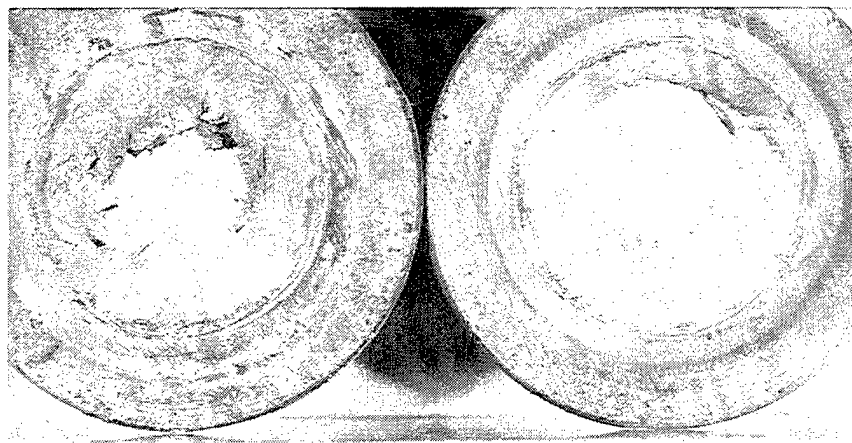
Figure 40. Enlarged views of the fracture surface under the buttonhead of four rivet samples after the pull tests revealing the extent of cracks (darkened area) observed due to corrosion. Sample 4 (95.37%), no. 14 (26.95%), no. 6 (19.62%), and no. 8 (11.60%).

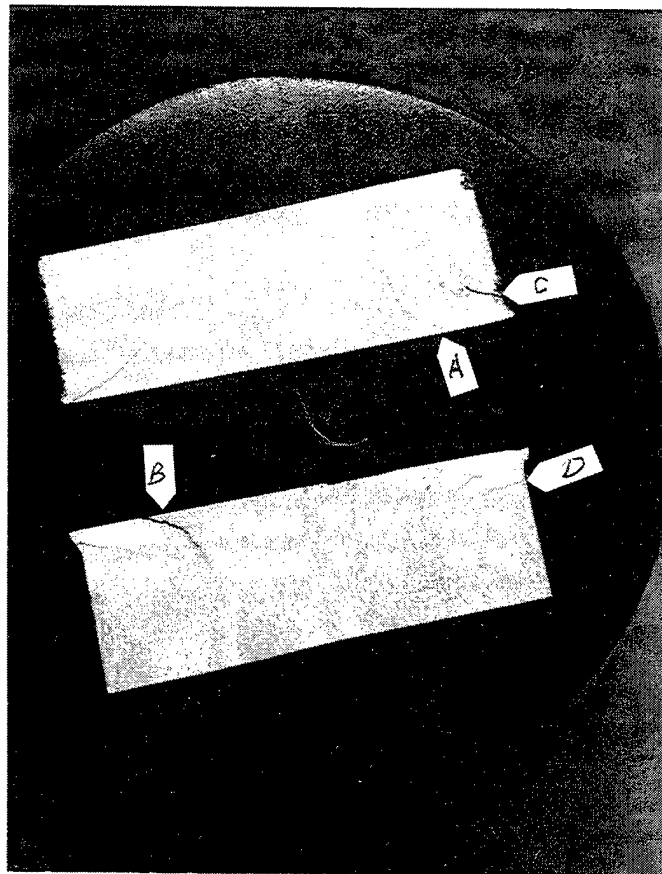
Figure 43. Enlarged view of the etched cross sections of the corroded AVL B rivet samples 10 (top) and 15, revealing stress corrosion cracks (dark curved lines) in the headless ends (arrows A and B) where the rivet buttonheads were sawed off. Most cracks observed were initiated at or near the fillets (partly seen in the photograph) and followed the grain flow caused by the head-forming operation. The microstructure at arrow C is seen in Figures 44 and 45, and that at arrow D in Figures 46 and 47. Magnification: 3.17 \times . Keller's etchant.

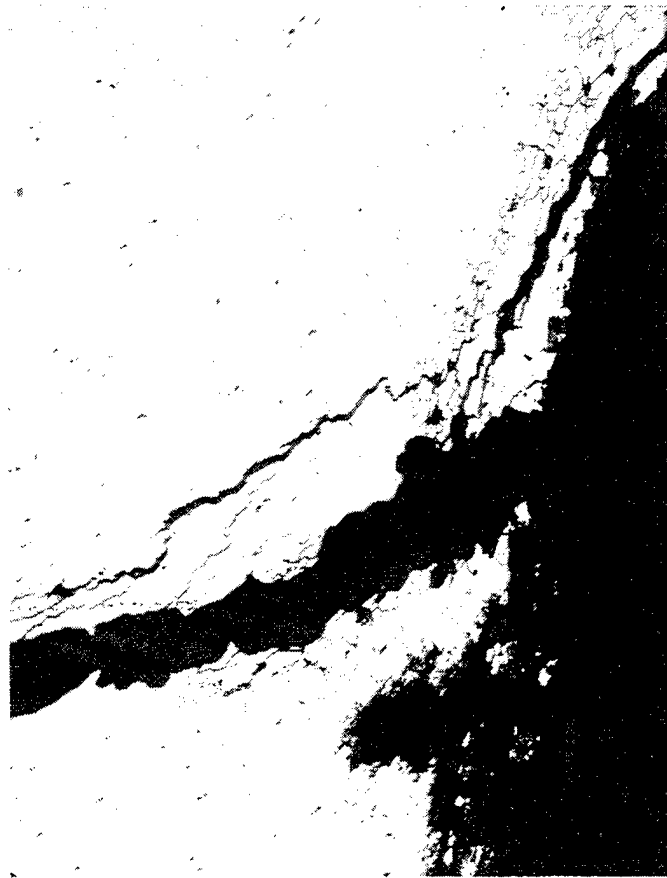
Figure 44. As-polished microstructure of stress corrosion cracks on the shank of corroded rivet sample 10 near the fillet. Note the intergranular corrosion on the surface of the shank (right side) and in the major cracks. Magnification: 100×.

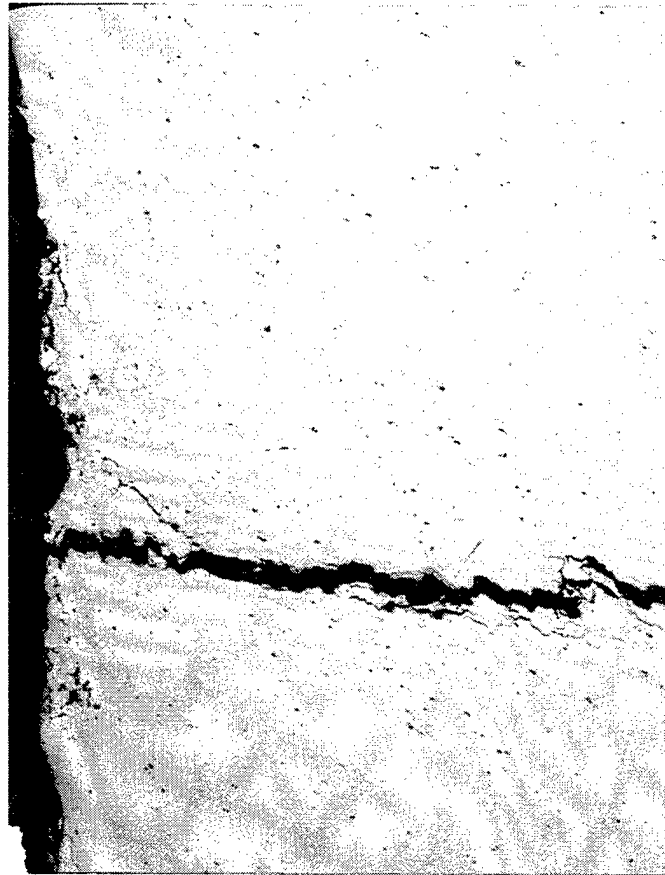
Figure 46. As-polished microstructure of stress corrosion cracks on the shank of the corroded sample 15 near the fillet area. Note the intergranular corrosion (not clearly seen in this photograph) on the surface of the shank (left side) and in the major crack. Magnification: 100x.

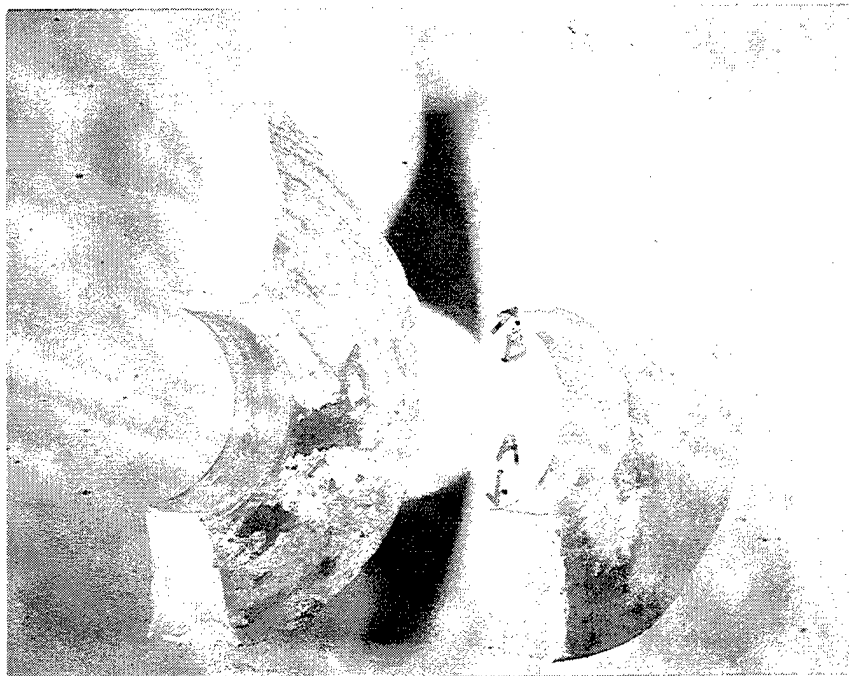
Figure 52. View of broken inboard female center hinge eyes. The piece on left is part of the inner hinge forging, and the other piece is part of the outer hinge forging that broke first at 95-ton load. Small fatigue cracks at A and B are seen in Figures 55 and 56.

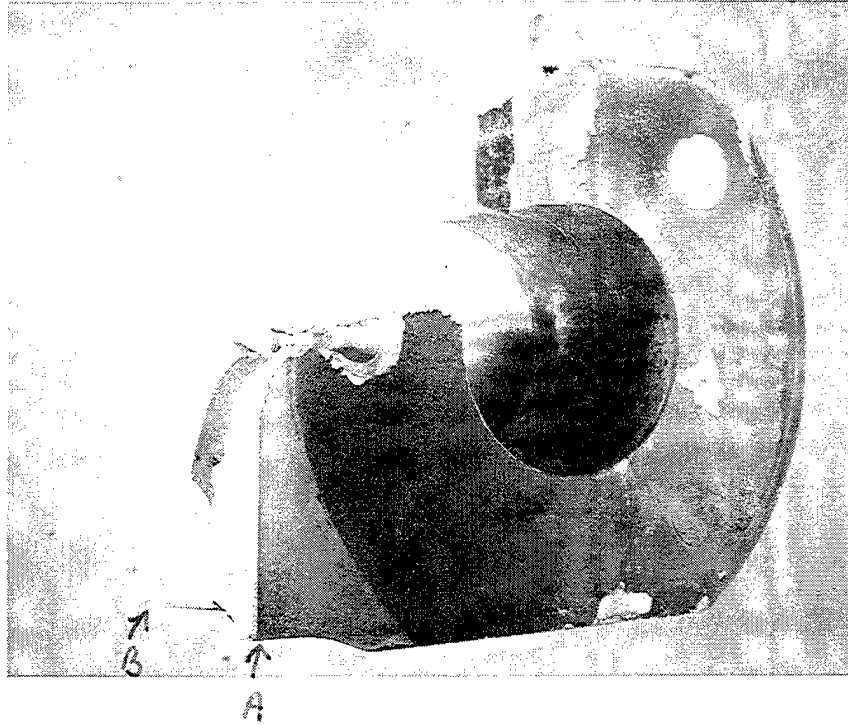
Figure 53. View of broken outboard bottom chord male connector eyes from the female center panel assembly after the failure test. The brittle fractures initiated at A and B because of the sharp machined fillets (straight edges). Closeup views of small fatigue cracks at A and B are seen in Figures 57 and 58.

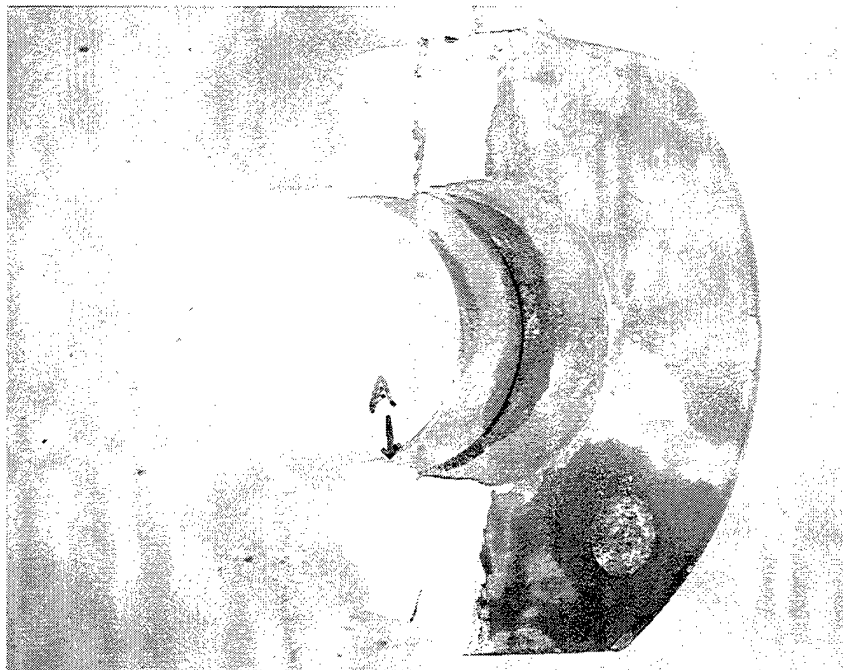
Figure 54. View of broken inboard bottom chord male connector eyes from the female center panel assembly. See Figure 59 for closeup view of the crack initiation site at A.

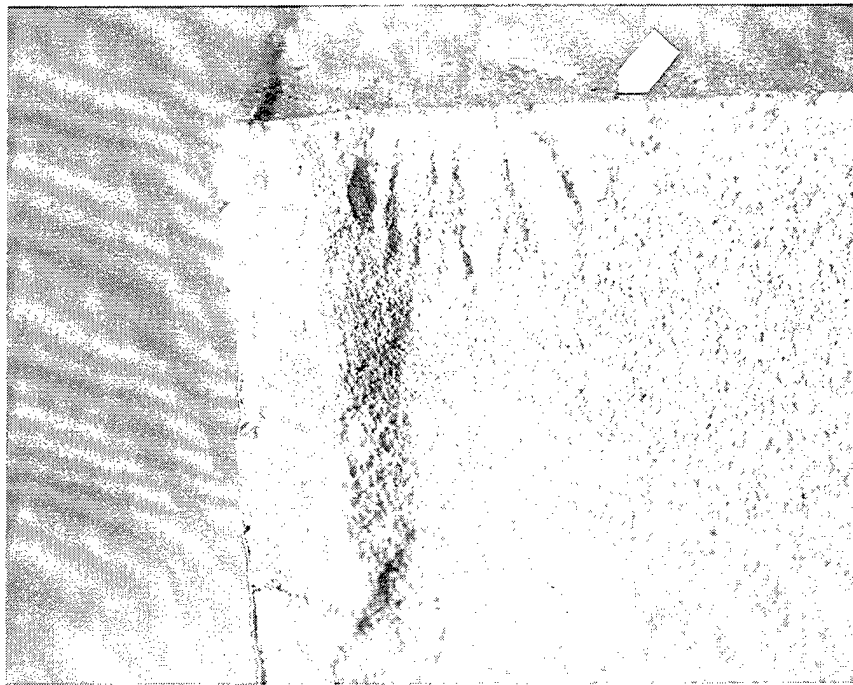
Figure 55. Closeup view of a small fatigue crack (arrow) at A in Figure 52. This eye piece of the forged female center hinge broke first at 95-ton load, initiating at this fatigue crack.

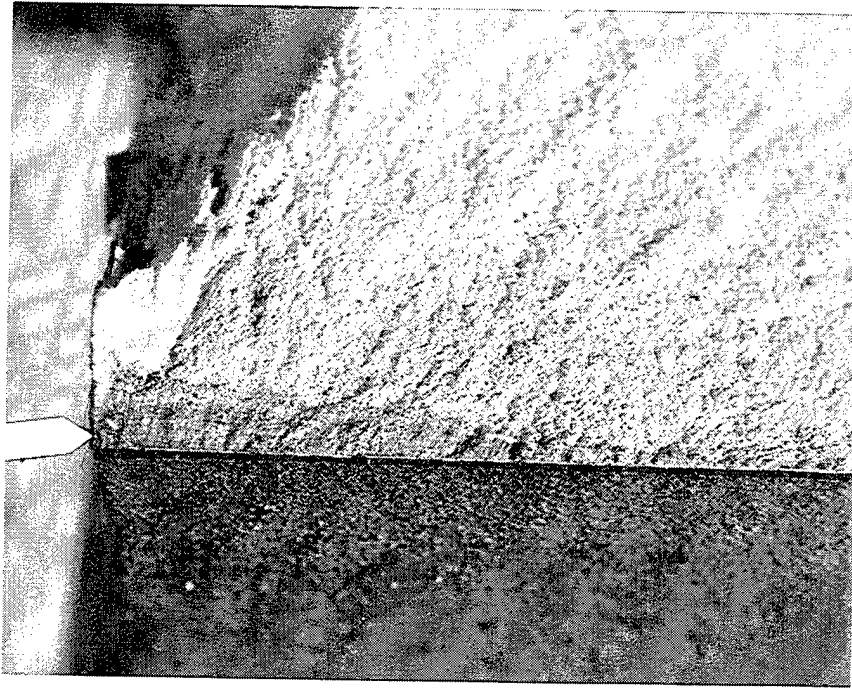
Figure 57. Closeup view of a small fatigue crack (arrow) at A in Figure 53 where it was initiated at the sharp machined fillets (straight edge).
